CASE STUDY

LEADING EDGE FALL HAZARD

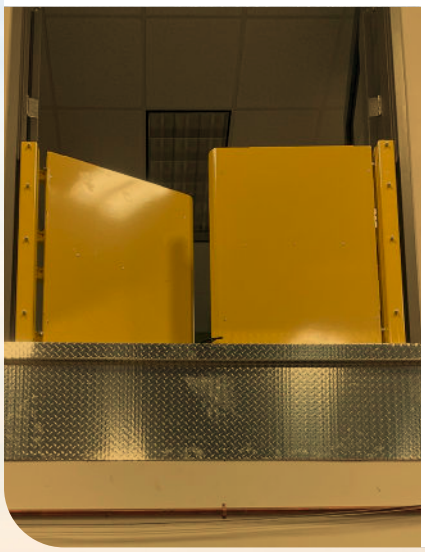
- Receiving area in warehouse
- Open access doors exposing leading edge fall hazard
- Issued OSHA citation for non-compliance

- Installed (2) single point swivel anchors with back plate at end of hallway near access doors
- Provided SRLs, harnesses and training on use of fall arrest system
- Eliminated hazard with passive fall protection (no training required) by installing mezzanine gate
