CASE STUDY

LEADING EDGE FALL HAZARD

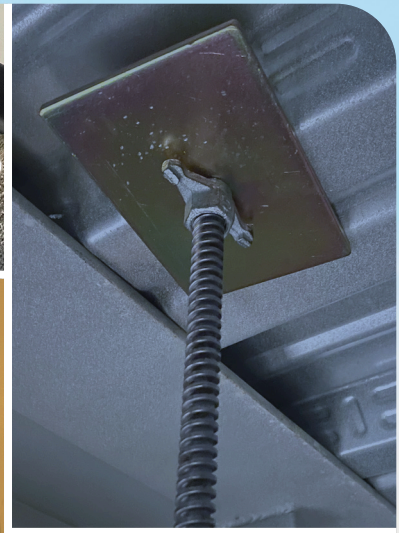
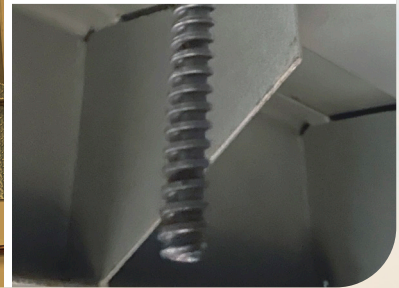
- Receiving area in warehouse
- Open access doors exposing leading edge fall hazard
- Issued OSHA citation for non-compliance

- Installed (2) single point swivel anchors with back plate at end of hallway near access doors
- Provided SRLs, harnesses and training on use of fall arrest system
- Eliminated hazard with passive fall protection (no training required) by installing mezzanine gate
